Case Study Farm 4 - Cairns

Turf Queensland

Assessing a new irrigation system and dealing with unforeseen events.

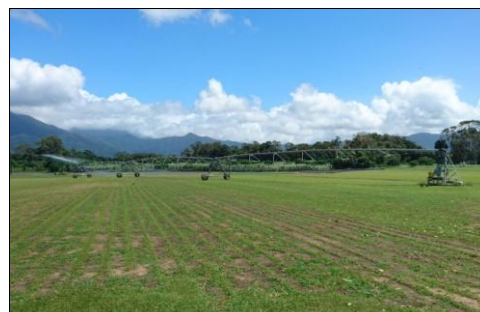
Figure 1: Centre pivot irrigation with end gun on trial area.

water use was not considered possible. However, the assessment identified that the coefficient of uniformity (79%) was below the industry benchmark (85%), and the flow rate from the end gun was too high. This is mainly attributed to the centre pivot operating at a higher pressure (400 kPa) than the design specifications (303 kPa).

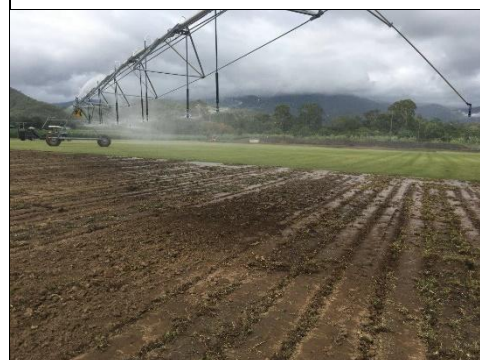
Figure 2: Irrigating the newly sprigged trial area.

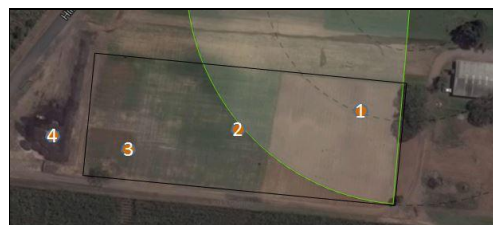
Figure 4: Location of soil samples taken within the trial area.

The soil analysis showed slight variations in soil structure and type as well as nutrient concentrations across the trial area. Two soil samples were slightly acidic with deficiencies in calcium and magnesium, with all samples deficient in the micro-nutrient boron. Sodium levels are not considered an issue, however it may be the cause of reduced calcium and magnesium concentrations in the soil profile due to the dissolving nature of the irrigation water. The addition of the 'Mill Mud' is supplementing nutrients to a degree. Further addition of calcium and magnesium is required over several months to return the soil to a nutrient balance. This will increase nutrient availability, improve soil health, and improve uniformity of turf growth throughout the year. Fertiliser type and application rates need to be determined in relation to turf nutrient requirements, the irrigation application rate, and soil infiltration rate to ensure optimum nutrient retention within the root zone for turf uptake.

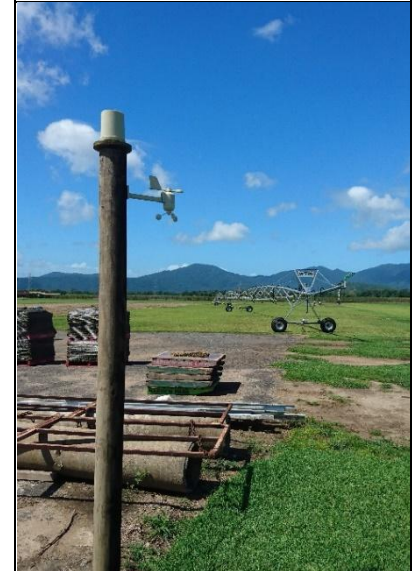
Figure 7: Wind sensor and rain gauge installed two meters high with no obstructions to ensure accurate readings.

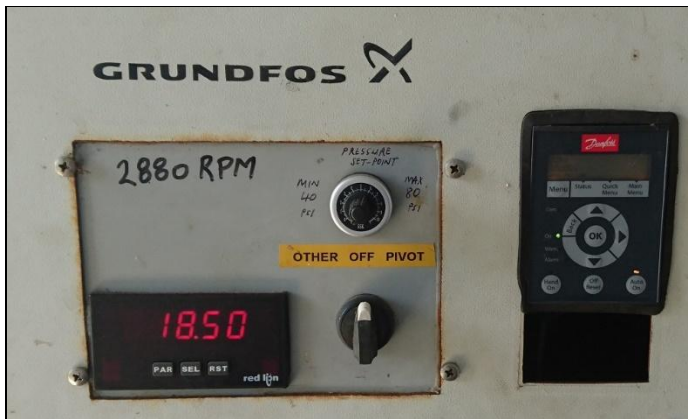
Figure 9: Pressure adjustment and power monitor upgrade for the VFD pump controller.

Although a full assessment of energy use was not possible at the beginning of the project, the upgrades made to the irrigation pump controller, for less than \$400, included a power/frequency monitor. This device indicates the kilowatts being used by the pump in real-time. Using a pressure adjustment control to increase or decrease the power frequency, the pumps output pressure can be changes to suit different irrigation systems. The data recorded at different operating pressures was used to estimate the energy use.

At the original higher operating pressure of 414 kPa (60 psi) pump energy use was recorded at 20.1 kW. After the controller upgrade, the pressure was adjusted to design specifications of 303 kPa (44 psi) and pump energy use was reduced to 6.63 kW. This equates to a yearly reduction in pump energy of 1444 kWh (41%). Pumping costs have been reduced by 59 kWh per mega-litre or \$12 per mega-litre pumped. With the commissioning of the second centre pivot and identification of the optimum irrigation schedule there is potential for energy use to be reduced further.

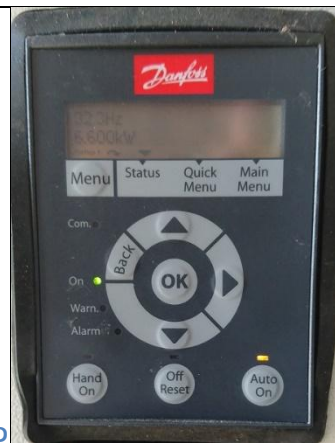
Figure 10: Energy use monitor indicating pump operating frequency and kilowatt usage.
