Case Study Farm 6 - Mackay

Turf Queensland

False positives can increase water use.

The project North Queensland Rural Water Use Efficiency - Irrigation Futures (NQ RWUE-IF) is a collaboration between the Queensland Government and Turf Queensland. The aim of the project was to provide training, information and support to Turf producers while assessing their farm practices and implementing alternative practices to improve water use efficiency, reduce input costs and increase productivity.

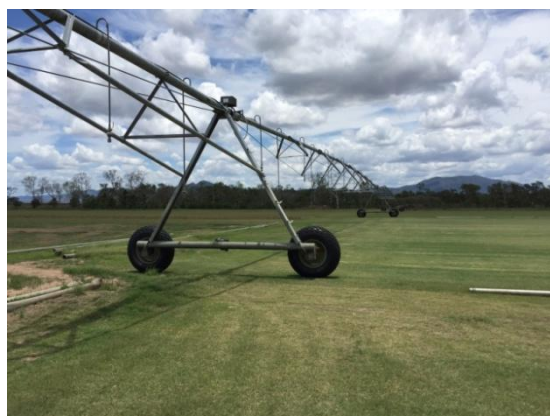
Figure 1: Lateral move irrigator on Case study Farm 6.

The farm has a water allocation of 100 mega-litres per year, but due to the regular rainfall in the region they rarely exceed 50% of their allocation. The turf is irrigated with a six span Reinke lateral move irrigator using a diesel hydraulic drive and supplied by the original single speed bore pump commissioned in the early 1980's. A second pump of similar size and age that draws water from a one mega-litre dam is used as a backup supply. The bore pump and lateral move irrigator has been customised, maintained or repaired as needed but no major upgrades had been done to the system.

The 12 year old Reinke centre feed lateral move irrigator is supplied water by a Southern Cross L series, turbine pump through approximately 1,100 metres of 150mm CL 9 PVC pipe and a 200 metre long lay-flat connecting hose. The irrigator was designed for a flow rate of 17.2 litres per second at 120 kPa (17.4 psi) pressure and is fitted with Nelson #23 D3000 static sprays designed to be pressure regulated at 42 kPa (6 psi).

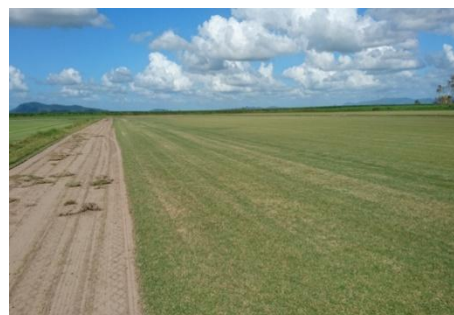
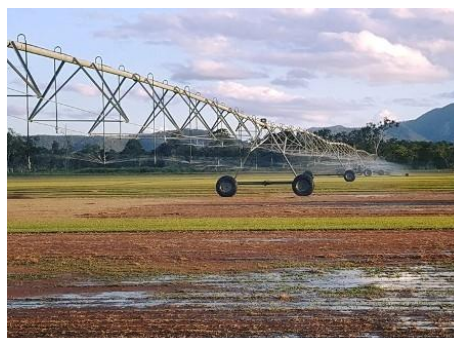
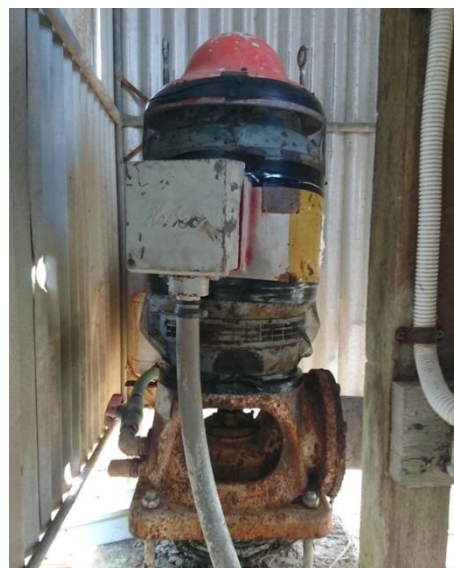
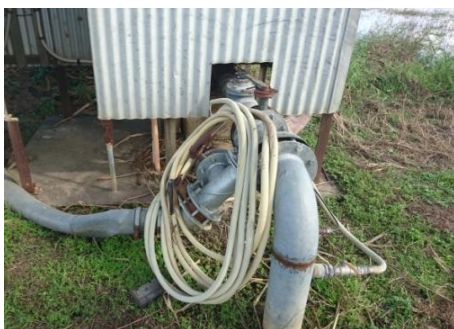
The system has been customised over the years as per irrigation equipment supplier recommendations in an attempt to increase uniformity of application and reduce water pooling on the surface. No irrigation system assessments had been conducted until this project. Customisation included changing sprinkler drop heights to two different heights, and replacing the individual sprinkler pressure regulators to higher rated units (138 kPa/20 psi) in an attempt to compensate for pressure variations in the system.

The old worn bore pump, although appropriate when commissioned, does not match the operating parameters (flow rate or pressure) the irrigator requires. A bleeder system or manual water by-pass valve, feeding the onsite dam, is used to adjust flow rates and operating pressures. A flow rate of 20.8 litres per second and an operating pressure of 125 kPa at the irrigator was recorded during assessment. A high pressure difference between the pump and irrigator of approximately 460 kPa was recorded. This suggested pressure loss due to increased pipe friction caused by the high flow rate or a leak in the underground supply pipe. Several rubber seals (grommets) and flexible fittings in the system had developed leaks, further adding to water and pressure loss. Regular manual adjustment to the by-pass valve was required when triggering an irrigation to compensate for flow rate fluctuations and the pressure loss between the pump and irrigator.

The ideal upgrade for this farm is to replace the old bore pump and pipe work with a new multi-stage variable frequency drive pump system and a larger main supply pipe to match the irrigator operating specifications and provide capacity for future expansion. However, due to the age of the bore, the casing and bore head must be evaluated for damage and structural integrity before installing a new pump system. Other recommendations included

- Reconditioning the existing bore pump to improve energy and pumping efficiency.
- Resetting sprinkler heights back to the designed height or to suit the sprinkler configuration used.
- Repair leaks in the system to reduce pressure and flow rate fluctuations, and reduce water loss.
- Install an inline filter to remove the debris that blocks the sprinklers or increase the sprinkler maintenance schedule to reduce sprinkler blockages.
- Replacing the sprinklers with new multi-trajectory sprinklers appropriate for the wind conditions on farm and design parameters of the lateral move irrigator.
- Replace the lay-flat supply hose with a solid or fixed diameter poly hose to reduce the friction losses in the supply pipe.

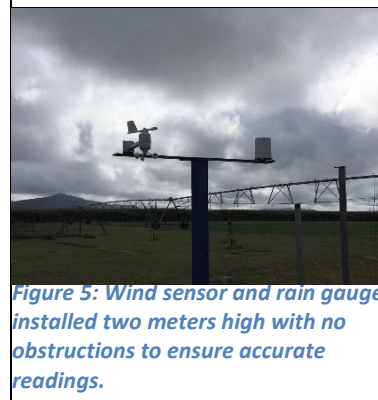
Figure 5: Wind sensor and rain gauge installed two meters high with no obstructions to ensure accurate readings.

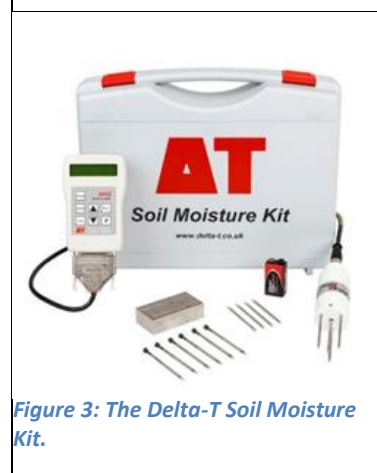
Figure 3: The Delta-T Soil Moisture Kit.

The Delta-T soil moisture probe is a handheld insertion probe that measures the percentage of moisture in the top 100 mm of the soil profile. Although turf can have a root depth greater than 300mm, discussions with turf producers suggest the top 100mm has the greatest influence on turf production. Using the Delta-T soil moisture probe to refine the irrigation schedule will allow more precise manipulation of soil moisture and nutrients within this limited root zone.
