# IMPLEMENTATION OF PRECISION IRRIGATION TECHNIQUES IN TURF PRODUCTION

## CASE STUDY 3

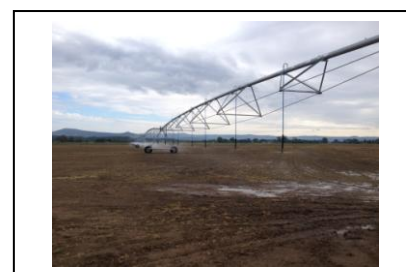
*Picture 1: Catch Can Test*

Irrigation consultants were engaged to assess the uniformity of water application of the centre pivot. The initial assessment on the new centre pivot was undertaken in May 2014 and showed that the Coefficient of Uniformity (CU) was 91.6% (industry benchmark 90%).

No recommendations were made to improve the new system.

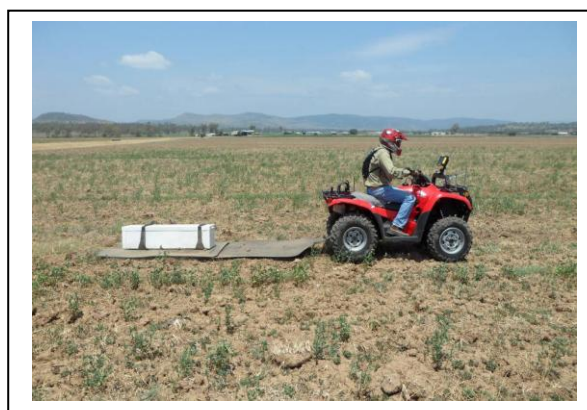
*Picture 2: Undertaking Soil Mapping Assessments on the newly ploughed*

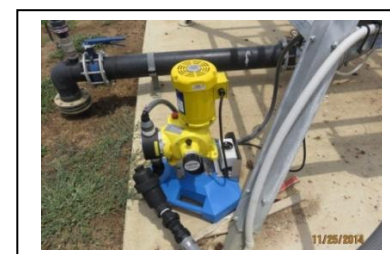
**Fertiliser and nutrient regime:** An Agri-Inject Fertigation unit was utilised that draws fertiliser from a bulk tank and injects solution uniformly into the irrigation system. The unit provides for precise metering and pumping accuracy and is directly joined to the pivot irrigator with fully interlocking connectors. Fertigation commenced on 29 January 2015.

*Picture 3: Fertigator*

Fertigation was commenced on the site using an injection system to apply liquid urea (once), chelated N:P:K plus a range of other chelated macro and micronutrients and sulphur (three times) and a microbial compound (once). However, being a new site, the area was also fertilised with chicken manure, and later, pig manure and granular N:P:K. The baseline site (old farm) was heavily fertilised, as the site was sandy and the soil depleted. Although there is reduction in fertiliser usage between the two sites, this is largely attributable to the manuring and granular fertiliser amendments required to grow turfgrass to a standard on two different soil types. The soil on the pilot site is
